Nevada
Environmental
Restoration
Project

DOE/NV--1133

Post-Closure Inspection Report for
the Tonopah Test Range, Nevada

For Calendar Year 2005

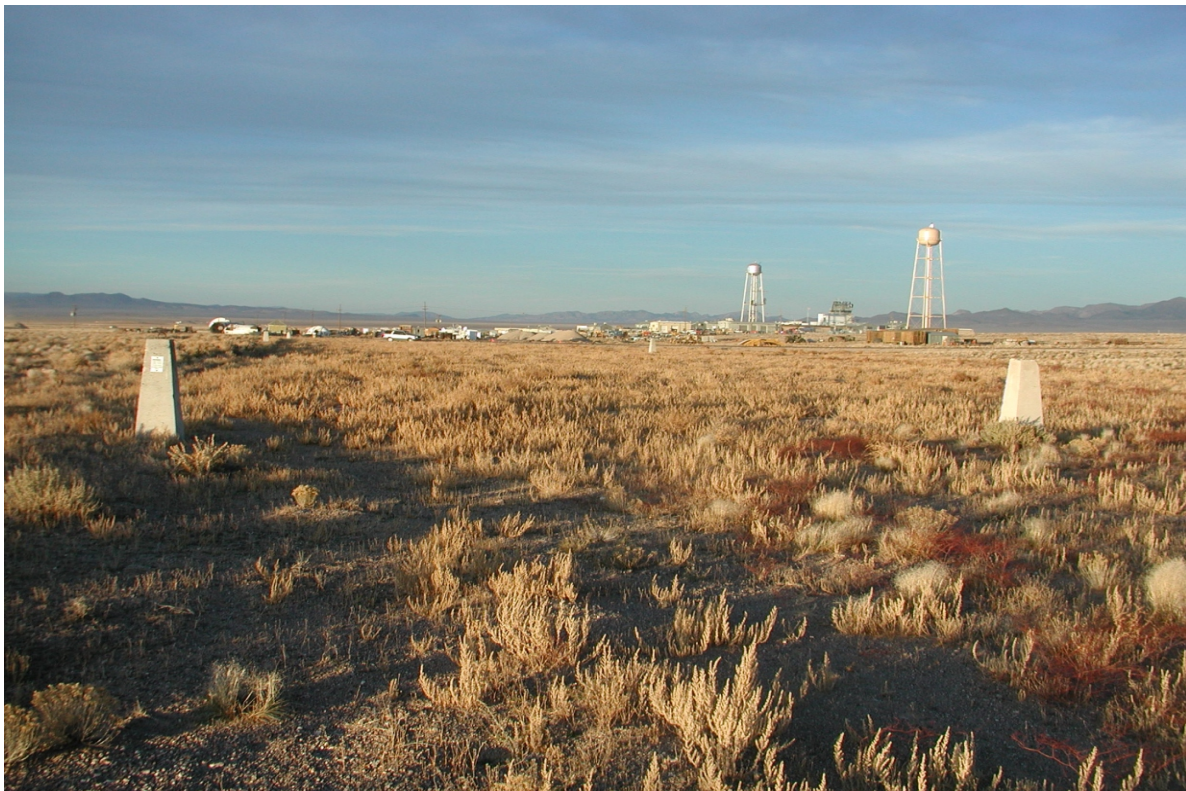
Photograph 26: CAU 424, Landfill Cell A3-4, looking north, 11/15/05

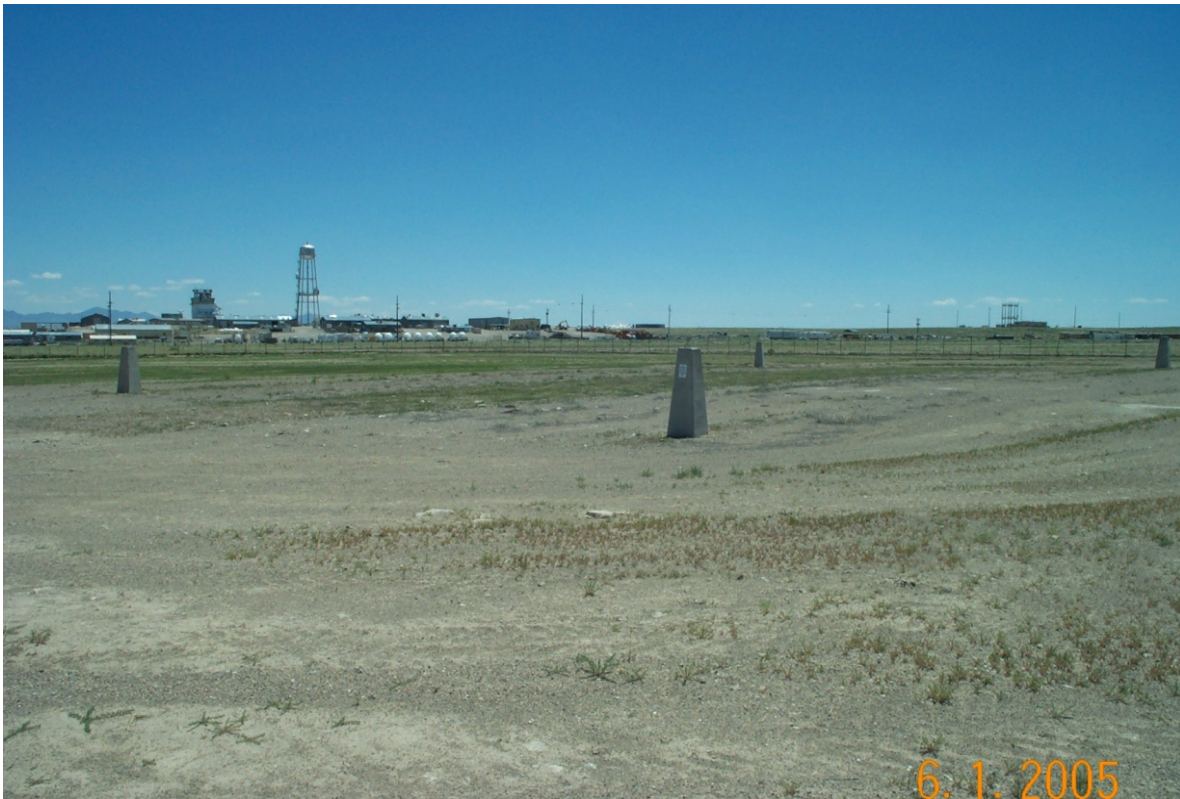
Photograph 27: CAU 424, Landfill Cell A3-5, looking southeast, 06/01/05

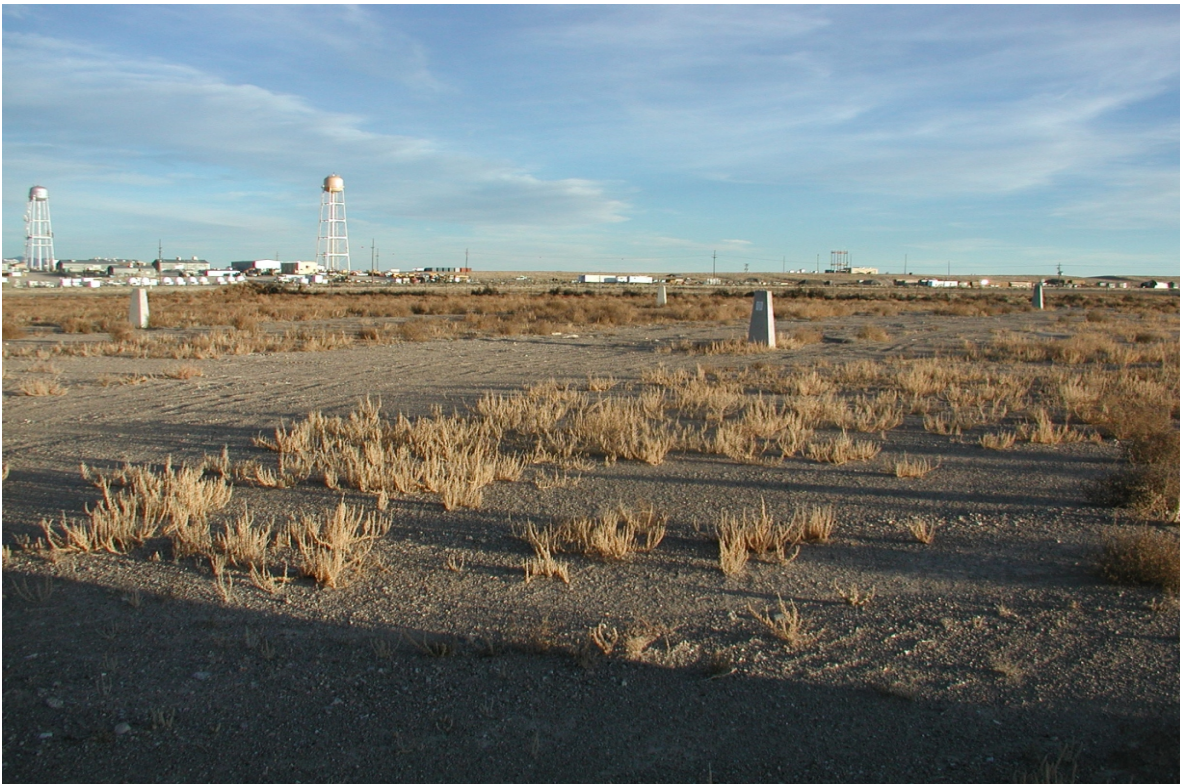
Photograph 28: CAU 424, Landfill Cell A3-5, looking southeast, 11/15/05

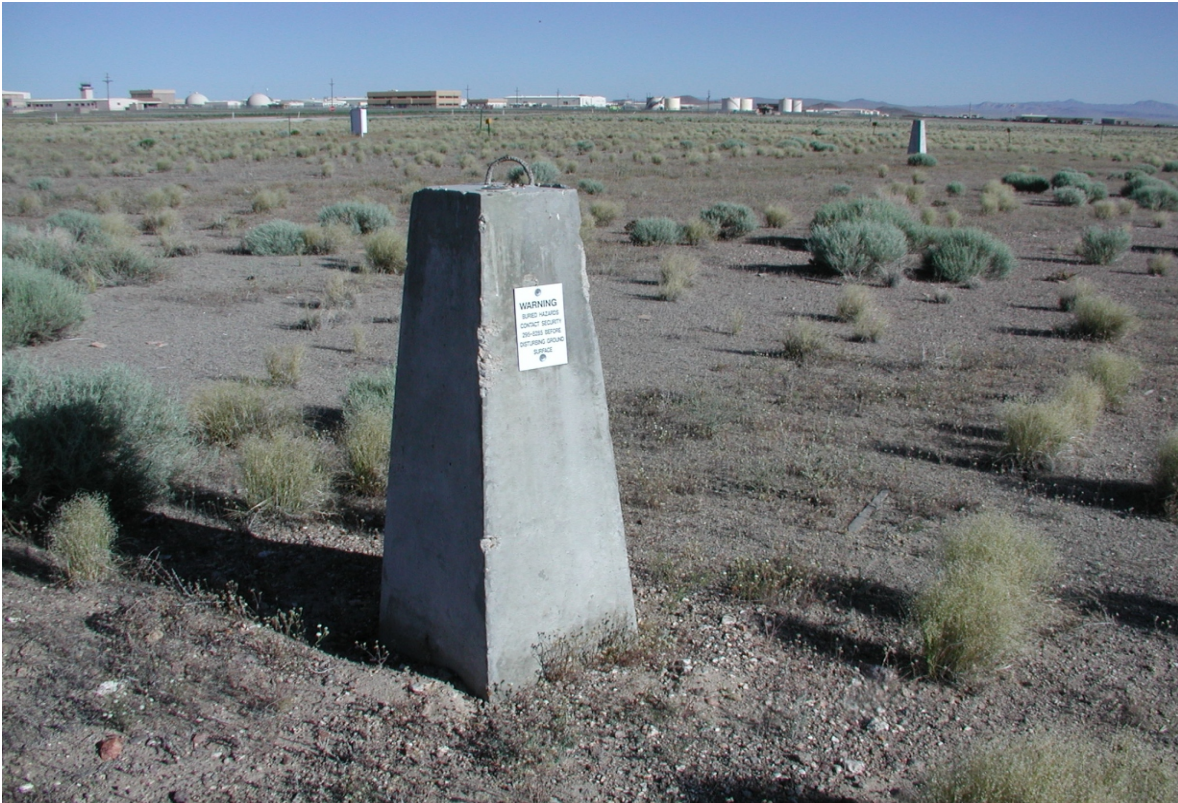
Photograph 29: CAU 424, Landfill Cell A3-6, looking northwest, 06/01/05

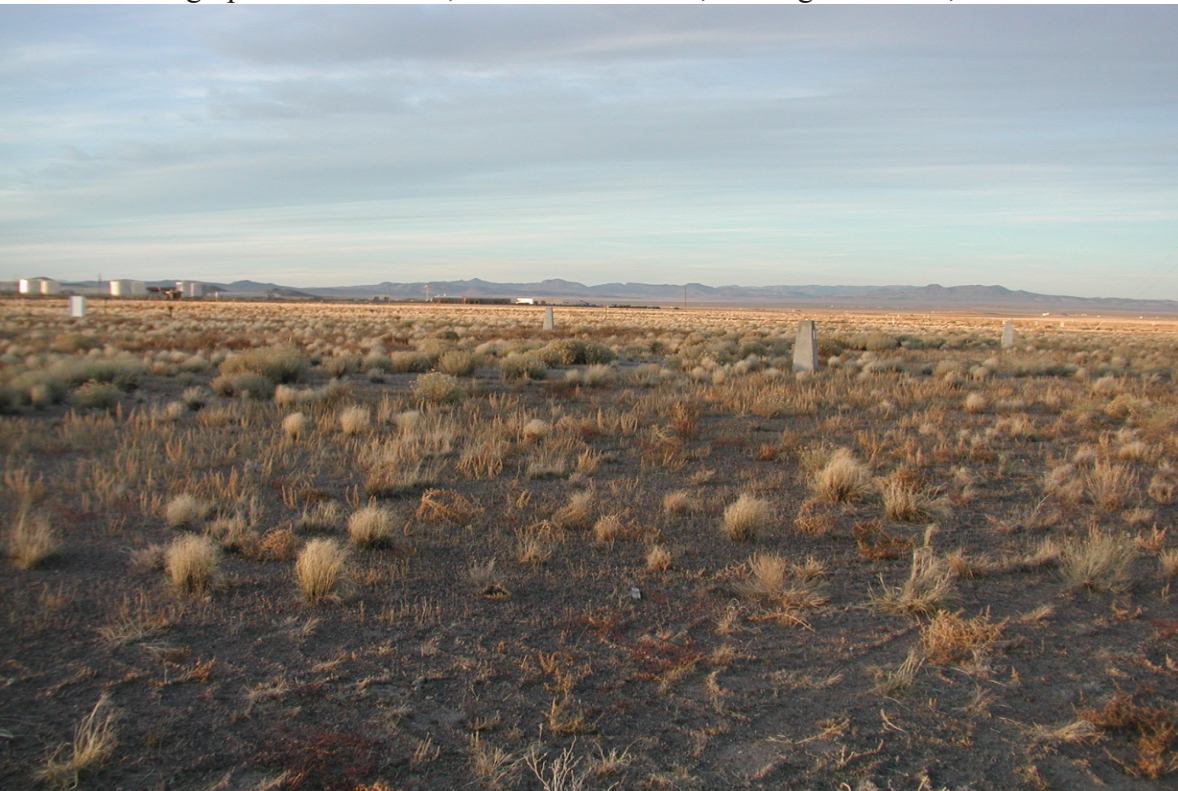
Photograph 30: CAU 424, Landfill Cell A3-6, looking northwest, 11/15/05

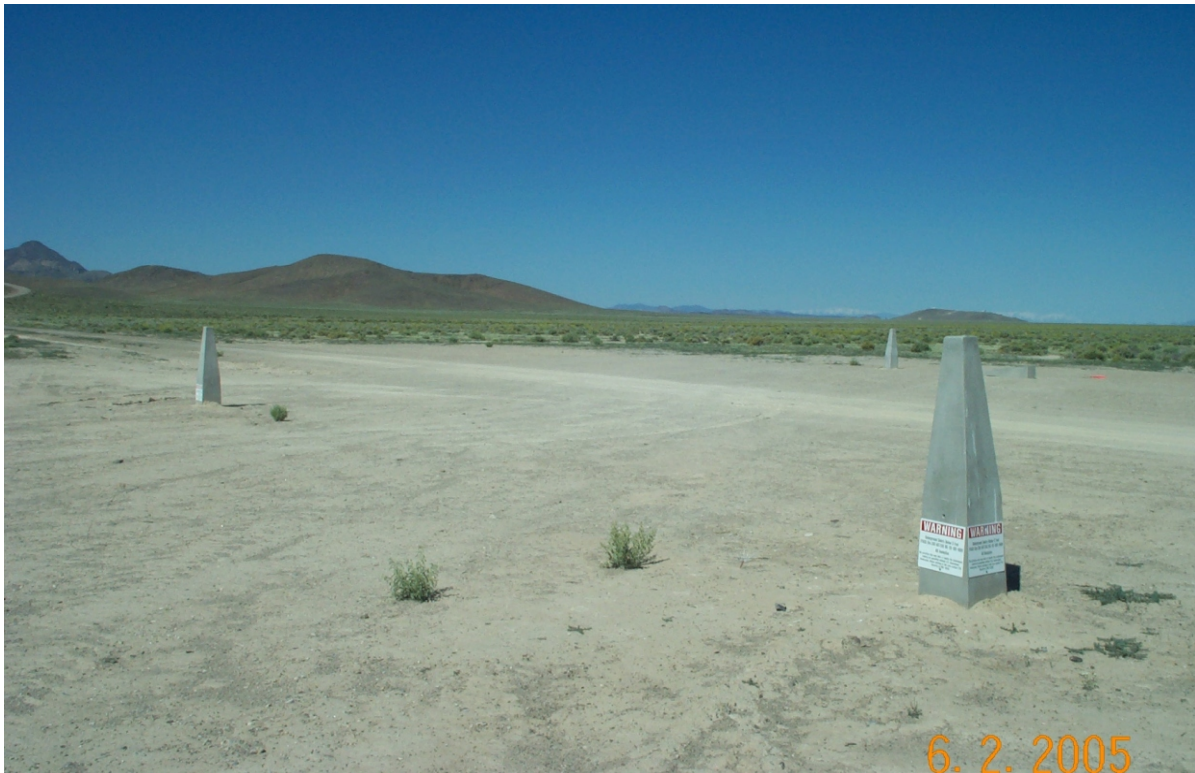
Photograph 42: CAU 453, soil subsidence, 11/16/05

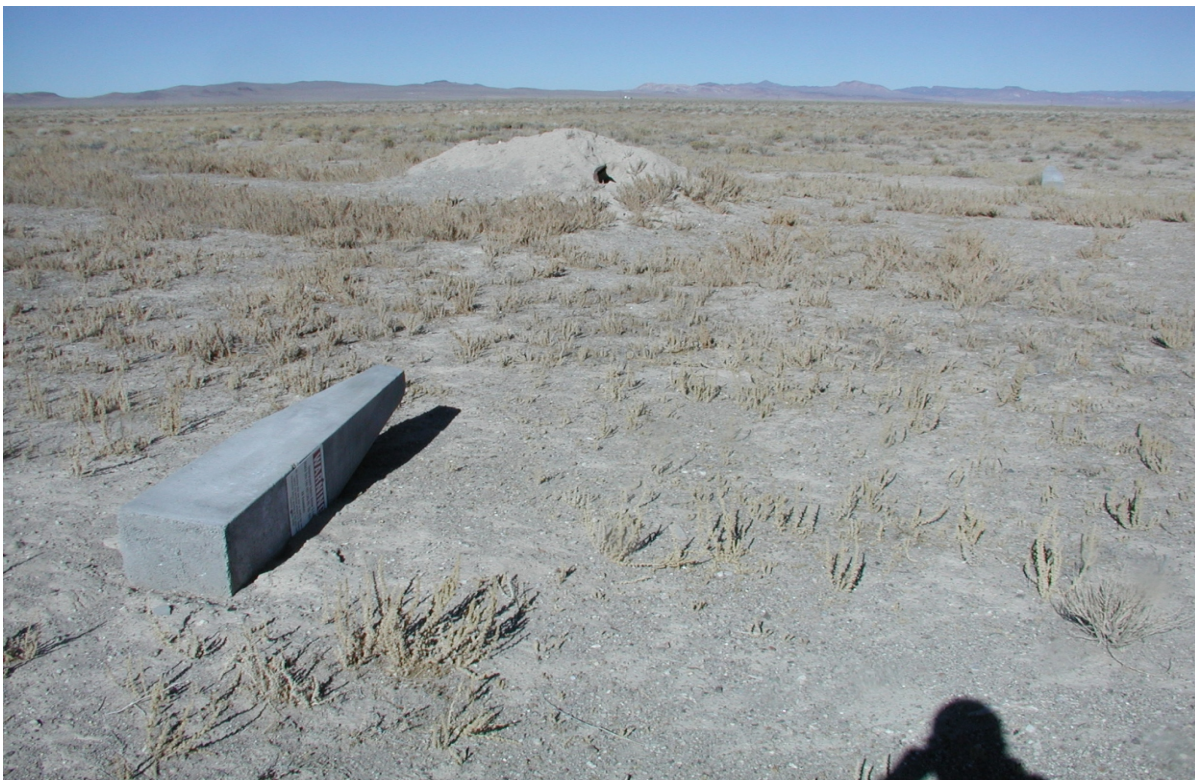
Photograph 43: CAU 487, A-8 anomaly, looking southwest 06/02/05

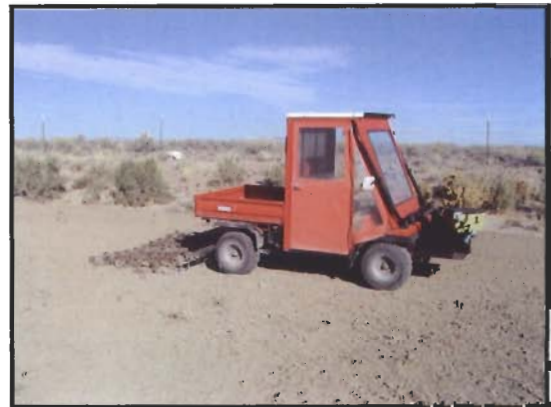
Figure 1. Kawasaki mule, equipped with a front-mounted broadcast seeder and drag chain, was used to prepare and seed the site.

Remedial revegetation efforts have occurred at two of the original sites. A flash flood swept through the center of the CAU 400-Five Points Landfill site in the summer of 2003. The perimeter fence along the northeastern edge of the site was damaged and many plants in the path of the flood waters were submerged or coated with a thin layer of mud. Many of the plants died leaving large areas without vegetation. The damaged fence was repaired and the site was seeded in the fall of 2004. Native plant species (Table 1) were seeded at a rate of 39.6 pounds per acre (lbs/ac) of pure live seed (PLS). Site preparation included the removal of dead vegetation and pulling a drag chain over the site to roughen the soil surface. The site was seeded using a broadcast seeder mounted on the front of an all terrain vehicle (ATV) (Figure 1). Drag chains were pulled behind the seeder to cover the seed (Figure 1).

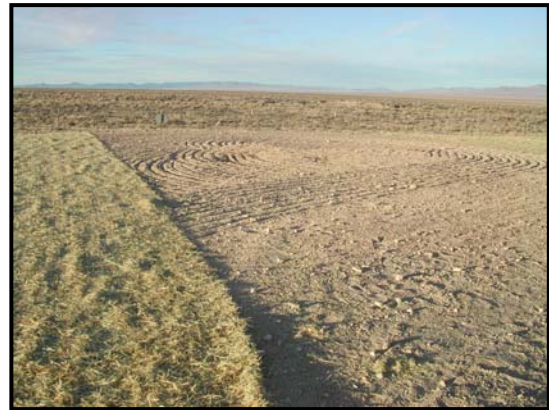
Figure 2. Installation of straw netting at the CAU 407 RADSAFE area.

CAU 407-Rollercoaster RADSAFE area was disturbed during the construction of erosion control measures after it was originally seeded in the fall of 2000. The construction activities resulted in the removal of all the vegetation on the surface of the cover cap. Over the past four years the soils on the cover cap had become compacted and erosion was occurring along the edges. In the fall of 2004 repair work was made to the erosion channels along the edges of the cover cap. Soil was hauled to the site and erosion channels were filled. The soil cover was then ripped (by a grader equipped with ripper teeth) to a depth of approximately 6 inches (in) to alleviate soil compaction. The site was seeded with a mix of native plant species at a rate of 22.2 PLS lbs/ac (Table 2) using the same equipment and process used for remedial work at the Five Points Landfill. After the site was seeded a straw mulch netting (Figure 2) was installed to protect the site from erosion. Supplemental irrigation was used at the site starting in February 2005 (Figure 3) and continuing through June. Supplemental irrigation was used at this site to ensure there would be sufficient soil moisture for seed germination and plant establishment. Establishment of a vegetative cover was necessary to prevent erosion along the edges of the cover cap. Approximately 3.75 in of supplemental precipitation was applied during irrigation events in December (1.0”), February (0.5”), March (1.0”), May (0.75”) and June (0.5”).

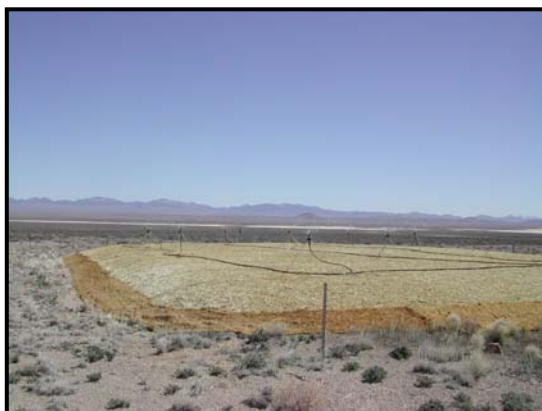
Figure 3. Irrigation system consisting of 15 sprinkler heads was used to apply approximately 3.75 inches of supplemental irrigation.

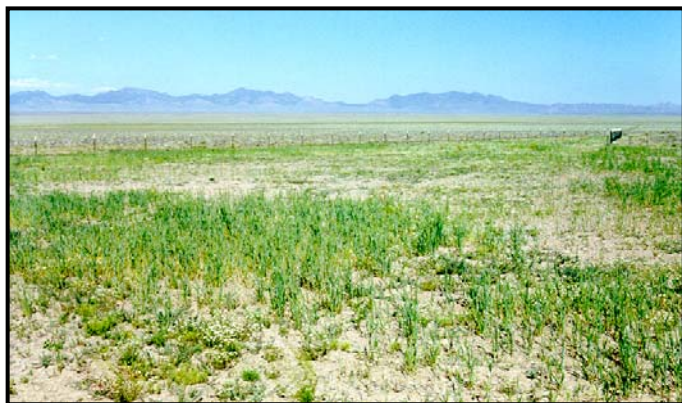
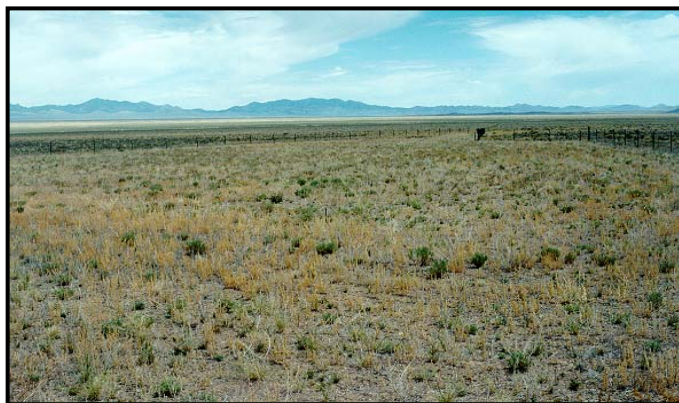
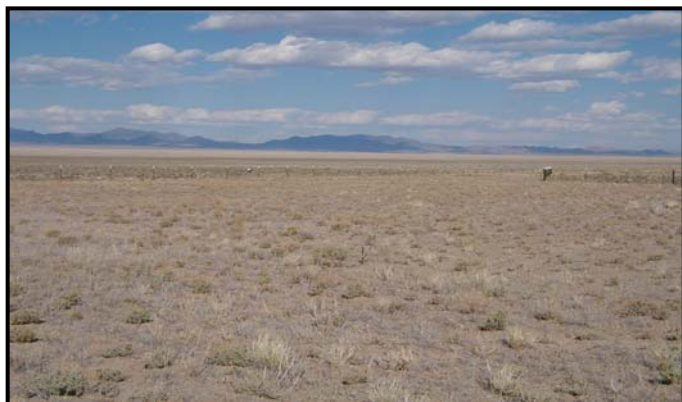
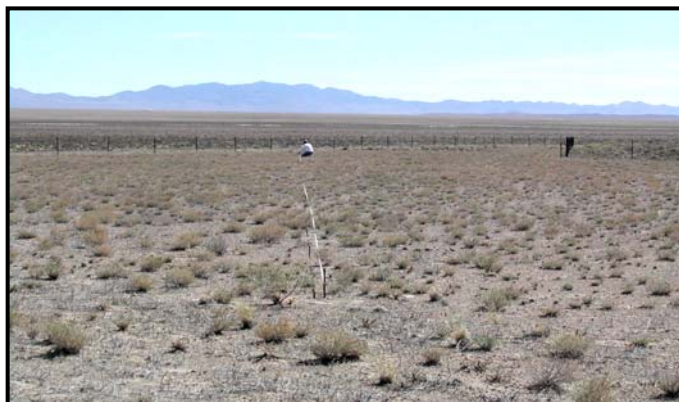
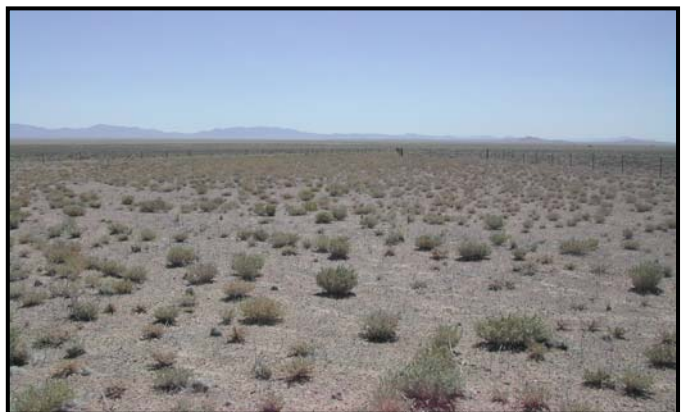
**CAU 400-BOMBLET PIT
PHOTOGRAPHIC REFERENCE POINT**

Plant cover increased by about 17% over an all time low of 7.5% in 2004 (Table 4). The composition of plant cover, like plant density, was 100% shrub, which is the same pattern as in the native plant community. Although density decreased slightly this year, those plants that have survived the drought conditions of the last few years, are showing good signs of growth.

There were no signs of herbivory or erosion at this site. The invasion of the site by halogeton, a noxious weed that dominated the area prior to closure, still does not appear to be a problem. After reaching a maximum density of 27.4 plants/m² in 1999, the density of halogeton declined to 0.1 plants/m² from 2002 to 2004 and this year was not found on the site.

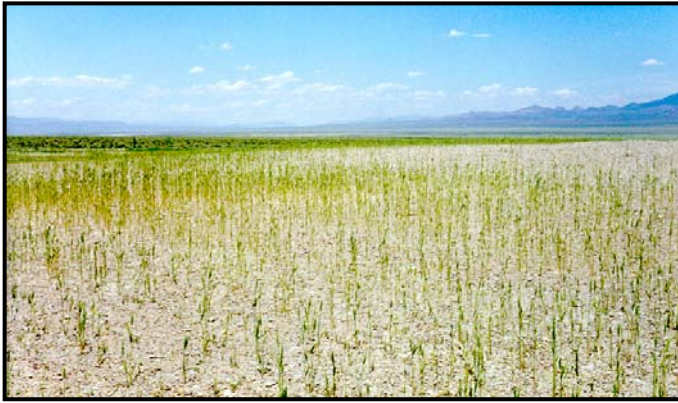
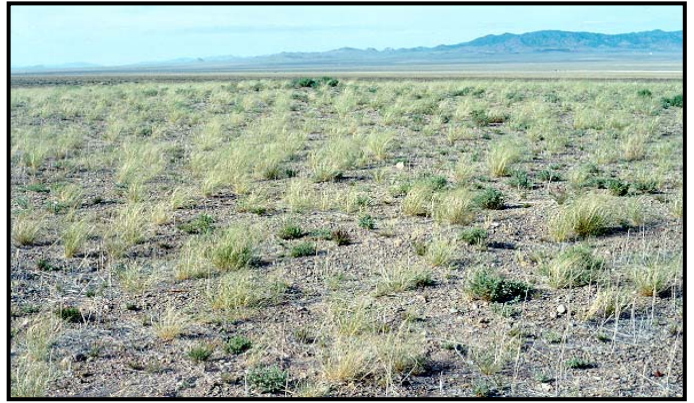
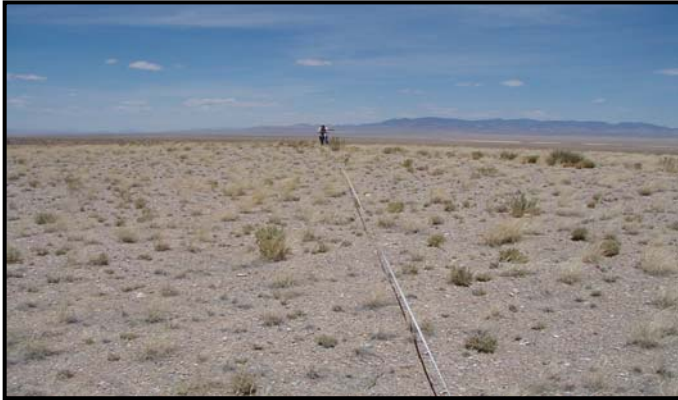
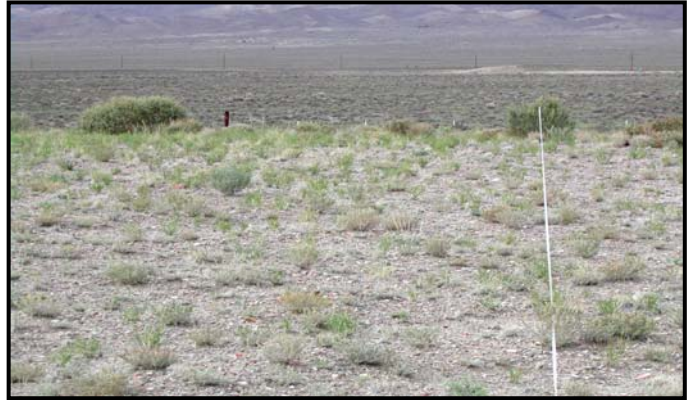
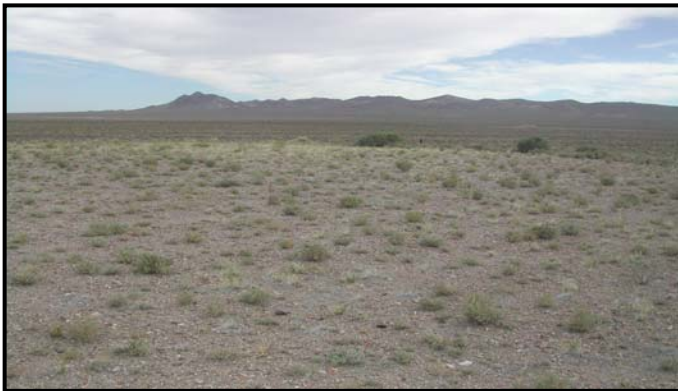
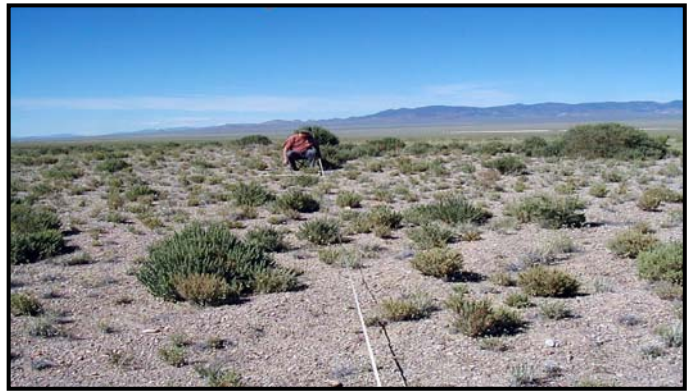
**CAU 404-ROLLERCOASTER SEWAGE LAGOONS COVER CAP
PHOTOGRAPHIC REFERENCE POINT**

Plant density is maintaining at about 13 plants/m² on the cover cap (Table 5). Eight of the plants are shrubs and five are grasses. Shadscale continues to be the most dominant species. Bud sagebrush and fourwing saltbush are present but at lower densities. Galleta grass is the most common grass. The only other grass encountered was Indian ricegrass which decline slightly this year in comparison to 2004. Squirreltail grass was not found last year but there were a few plants encountered this year. There was an abundance of annuals this year, more than in any other year.
